TB-2077

## WORKMANSHIP CRITERIA FOR VHDM DAUGHTERCARD CONNECTORS

Revision "M"

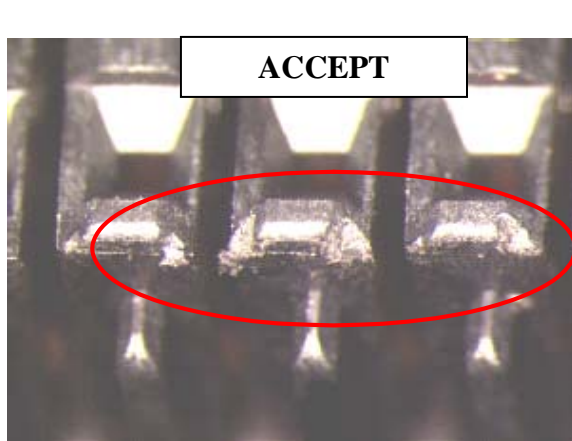
Figure 8.4 shows a dented signal pin window frame standoff from handling (8.4). Figure 8.5 shows dented frame areas from a backplane shield hitting the surface of multiple frame standoffs (8.5). Both conditions are acceptable.

Figure 8.4. Signal pin window frame dent.

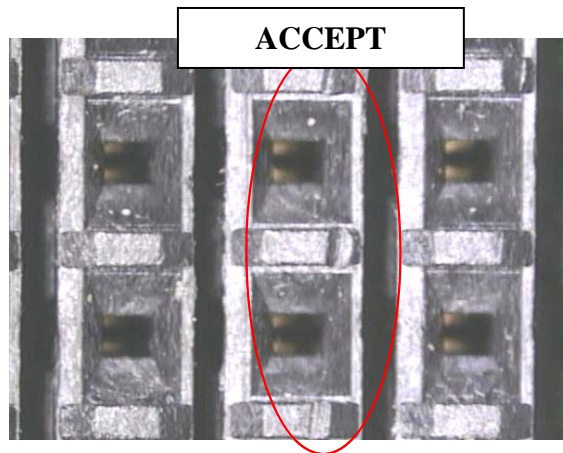
Figure 8.5. Signal pin window standoff dent.

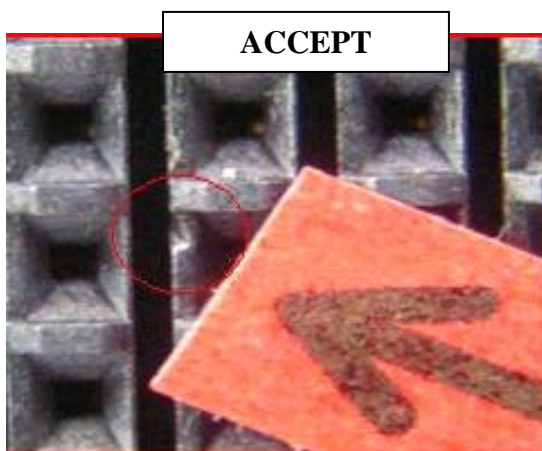
Figures 8.6 shows dented plastic on the signal pin window frame. Figure 8.7 shows dented window frames and standoffs from a backplane shield hitting the face due to improper mating. Both conditions are acceptable because they do not create obstructions to the signal pine of shields when mating.

Figure 8.6. Signal pin window frame dent.

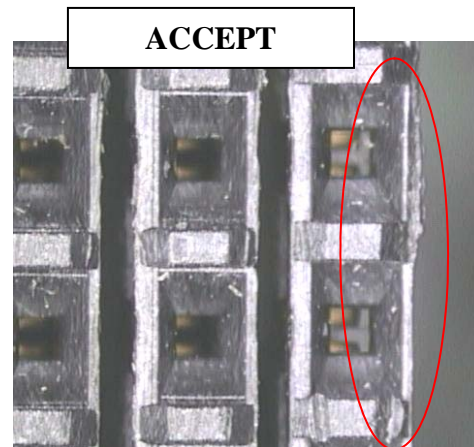
Figure 8.7. Signal pin window frame dent.

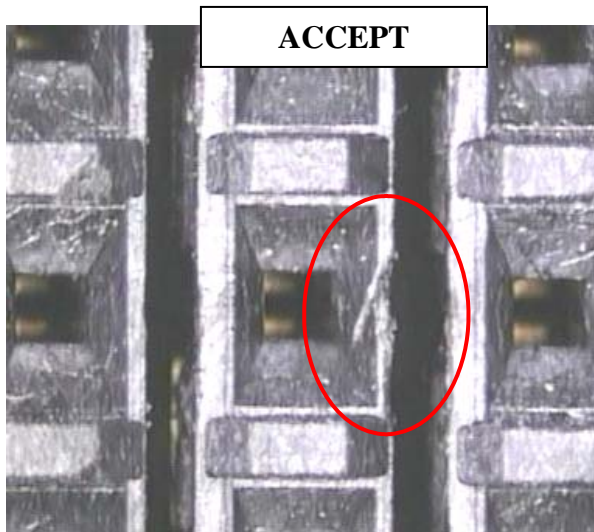
Figure 8.8 shows loose plastic from a window frame area protruding into the signal window. The plastic is loose and very thin in size. The plastic sliver is typically a result of the chevron of the shield conditioning to the mating wafer. Figure 8.9 shows signal pin lead in wear from multiple mating events. The lead in area only has surface wear and the window and shape of the lead in is still in tact. This wear will not impact the mating process. Any dent in the mating window under  $\frac{1}{2}$  of the signal pin size is acceptable and will not impact mating. Both conditions are a result of normal mating cycling and are acceptable.

Figure 8.8. Signal pin window frame loose plastic.

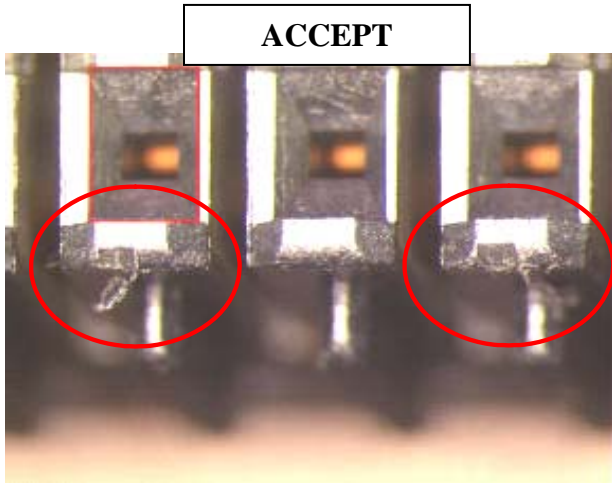
Figure 8.10 is loose plastic on the outside of the window frame standoffs. Figure 8.10 is a result of normal mating cycling and is acceptable.

Figure 8.10 Signal pin standoff loose plastic.

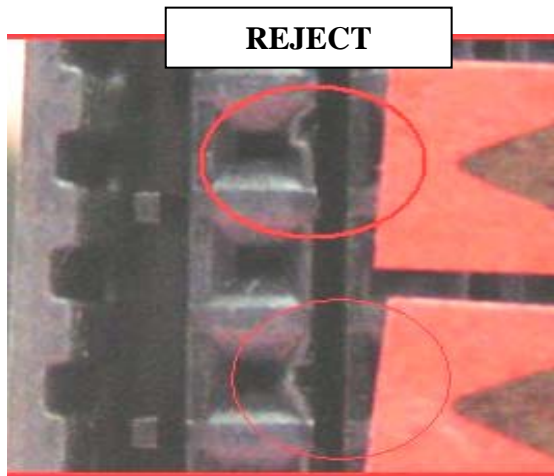
Dents and loose plastic in window frame area that creates damage in the lead in window or blocks signal pins or shields from mating are rejectable. The following figures show conditions that are a result of handling or mating that impact the ability for the connector to perform, and are to be rejected. Components that are rejected should be reworked per Amphenol-TCS recommendations (refer to Section 2.0). Figure 8.11 shows window lead in areas that are deformed as a result of improper mating. Figure 8.12 shows window lead in areas that are deformed as a result of improper handling. These conditions are to be rejected.

Figure 8.11. Signal pin window lead in dent.

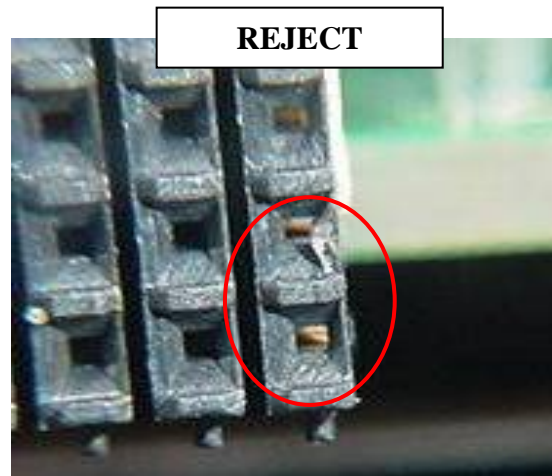
Figure 8.12 Signal pin window lead in dent.

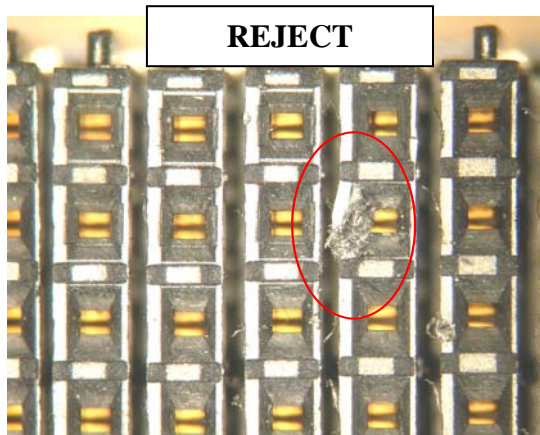
Figure 8.13 shows the shield slot being obstructed by plastic damage. Figure 8.14 shows a hole in the window lead in area as a result of an improper mating. These conditions are to be rejected

Figure 8.13. Shield slot obstruction.

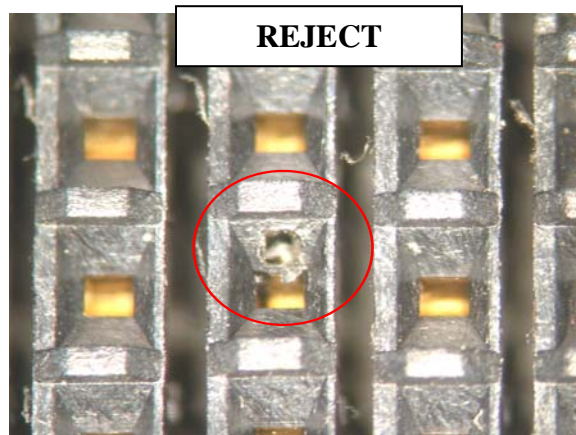
Figure 8.14 Signal pin window hole.

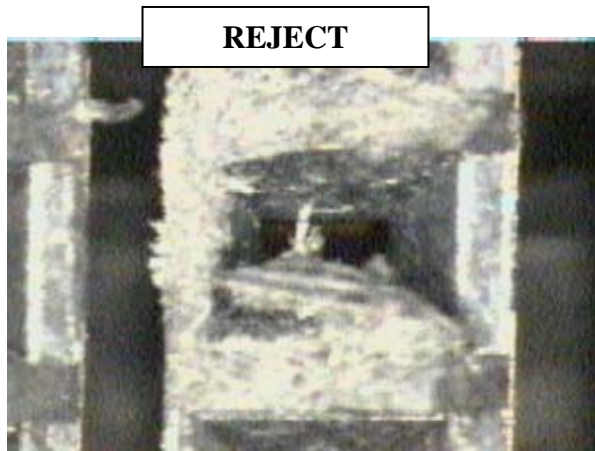
Figure 8.15 shows a window lead in areas that is deformed and is obstructing the signal window. Figure 8.16 has a signal lead in that is damaged. The shape of the lead in is deformed. These both may impact mating and are to be rejected.

Figure 8.15 Signal pin window obstruction.

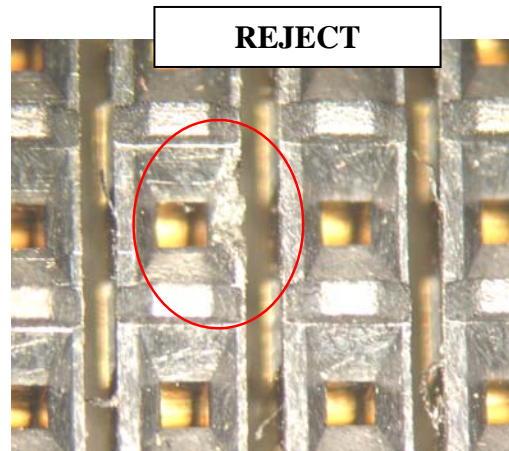
Figure 8.16 Signal window lead in damage.

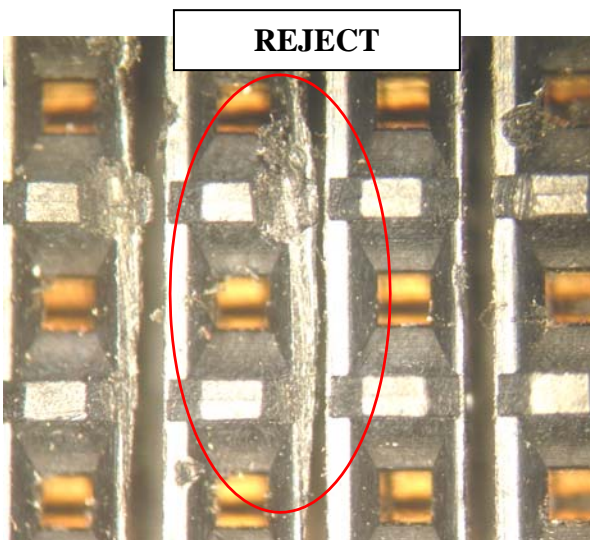
Figure 8.17 shows the shield slot obstructed by plastic damage. Figure 8.18 shows a damaged standoff that has created a shield slot obstruction. These conditions are to be rejected.

Figure 8.17. Signal pin window obstruction.

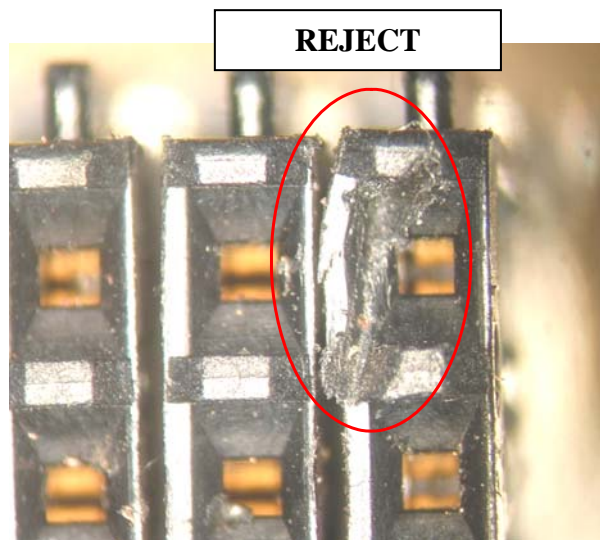
Figure 8.18 Shield slot obstruction.

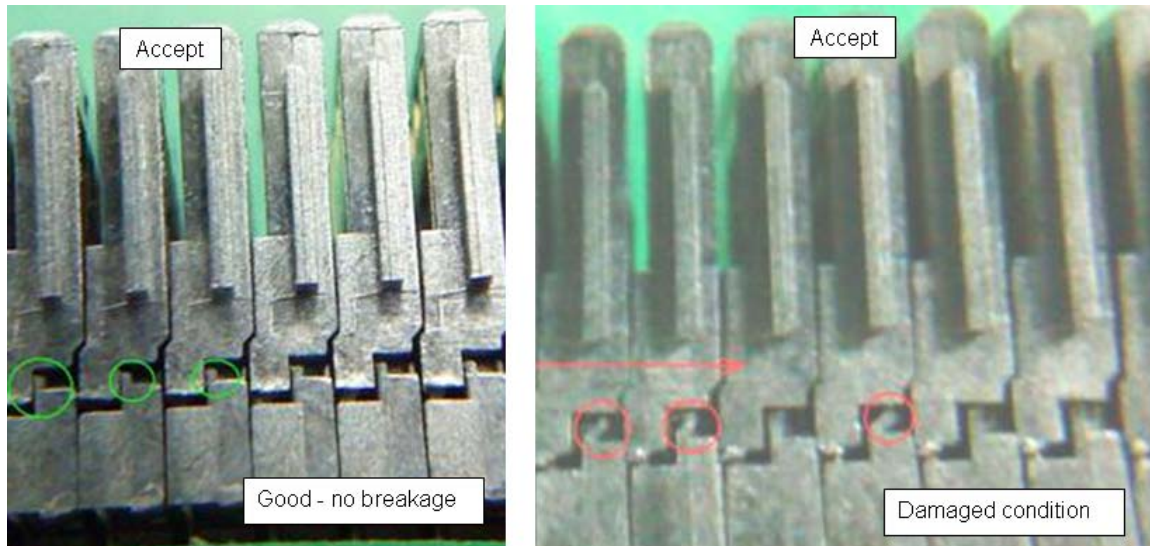
Figure 8.18.1 shows the signal wafer and shield wafer assembly with minor plastic damage. The damage is in the area where the signal tines engage with the shield mold. This minor plastic deformity is acceptable for use.

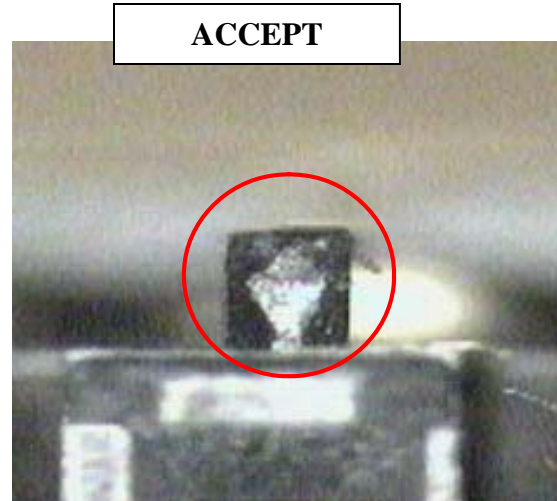
Figure 8.22 Mating rib tip dent.

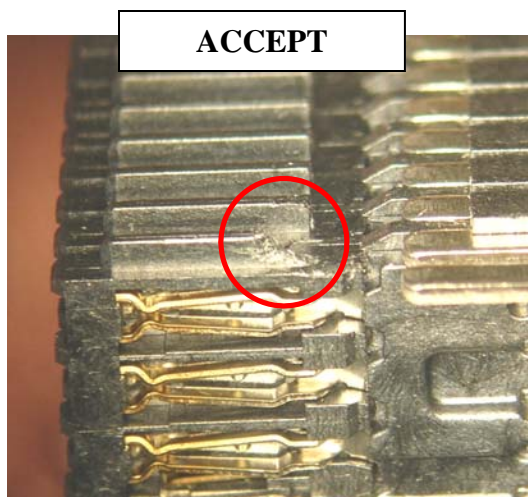
Figure 8.23 shows mating ribs that have the rear portion missing due to handling. This is acceptable because the rib is structurally intact and poses no risk to mating and is not missing more than 25% of the rear of the rib. No loose debris should be present. Figure 8.24 shows a mating rib with a side dent. This is acceptable because the tip of the rib is intact and the dent is at the rear of the rib. There is no risk to mating due to the tip being in tact. The maximum deformation of any rib in this manner is 25% increase in overall width.

Figure 8.23. Mating ribs with rear removed.

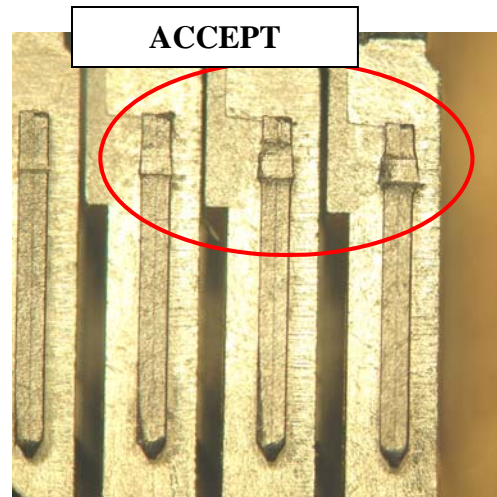
Figure 8.24 Mating rib side dent.

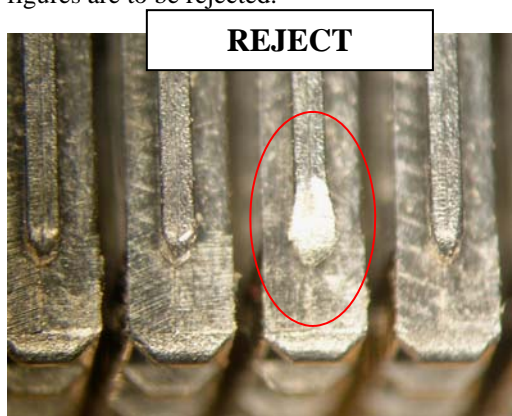
Rejectable damage to the wafer mating ribs is defined as defects that prevent the VHDM wafer from mating successfully with a backplane slot. Due to the design of VHDM, every wafer must have intact wafer ribs. Any damage equivalent to or exceeding the examples shown should be repaired per Amphenol-TCS recommendations (Refer to Section 2.0). Figure 8.25 shows a dented wafer rib tip. The dent deforms the tip of the rib, damaging the lead in and the gathering ability of the rib. Figure 8.26 shows a missing and a broken wafer rib tip. These conditions prevent the wafer from properly gathering and aligning prior to the signal pins entering the window area of the rib. Both of these figures are to be rejected.

Figure 8.25. Mating ribs with rear removed.

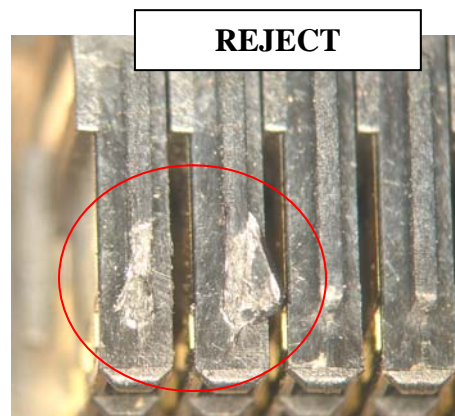
Figure 8.26 Mating rib side dent.

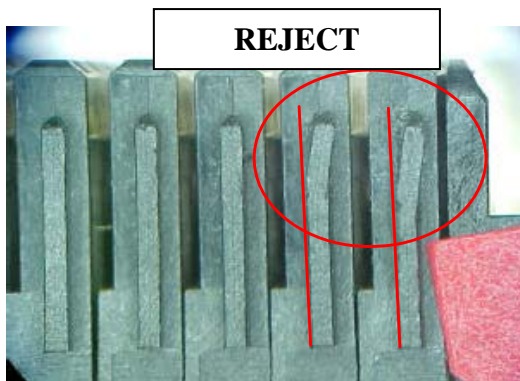
Figure 8.27 shows broken wafer ribs at the tip. Figure 8.28 shows missing wafer ribs. These conditions prevent the wafer from properly gathering and aligning prior to the signal pins entering the window area of the rib. Both of these figures are to be rejected.

Figure 8.27. Mating ribs with rear removed.

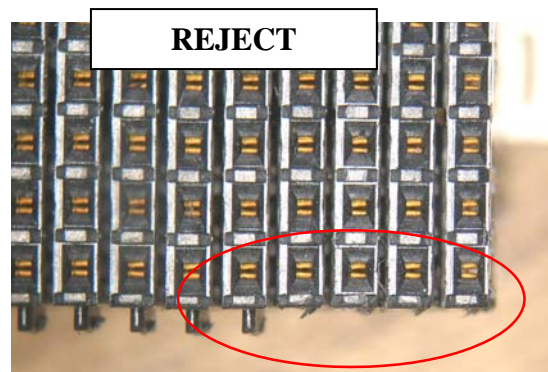
Figure 8.28 Missing mating ribs.

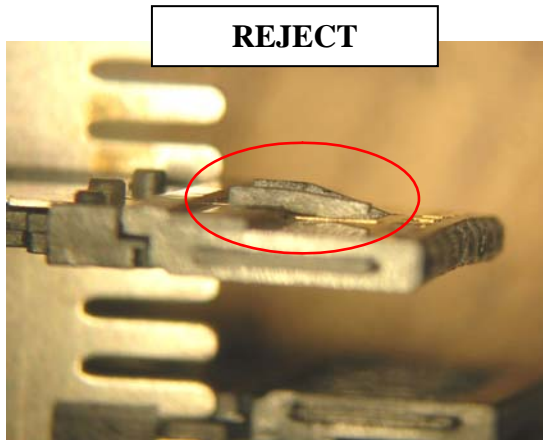
Any damage to the shield fingers that bends or breaks the fingers is to be rejected and repaired as recommended by Amphenol-TCS (See Section 2.0). Figure 8.31 shows a bent shield finger. Figure 8.32 shows missing shield fingers. Both of these conditions are to be rejected.

Figure 8.31. Wafer shield fingers.

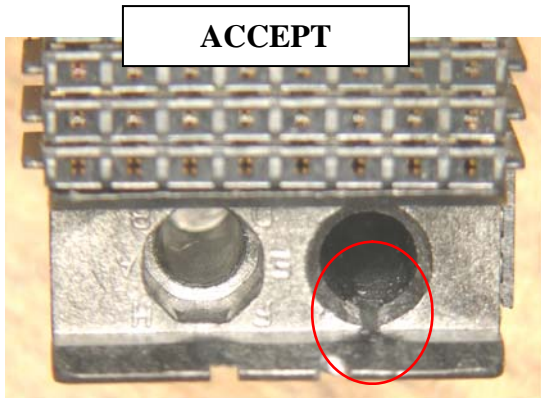
Figure 8.35 shows a wear track on the guide module from normal mating and un-mating. Figure 8.36 shows a stub from a guide pin during a mating attempt. Both of these conditions are acceptable because they do not degrade the gathering capability of the guide module.

Figure 8.35. Guide module mating wear.

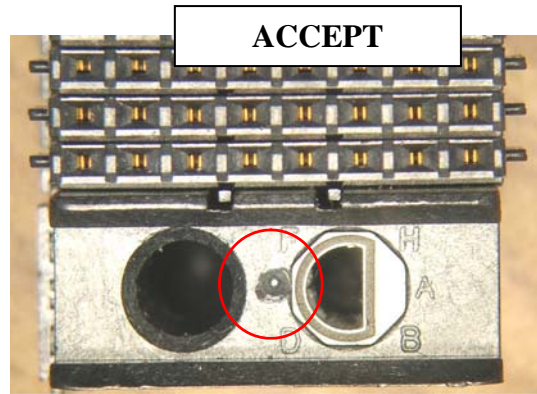
Figure 8.36 Guide module minor stub.

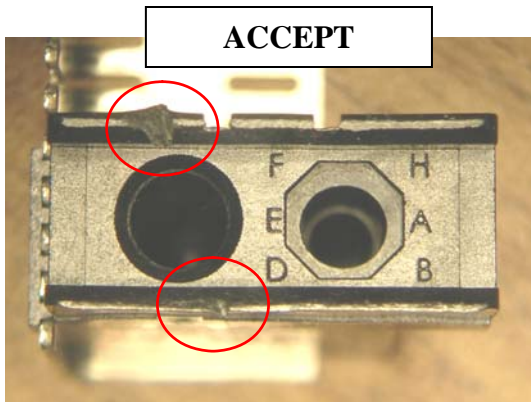
Figure 8.37 shows a dent on the guide module wing as a result of handling. This condition is acceptable because the wings provide NO gathering capability to the guide module.

Figure 8.37. Guide module edge dent.

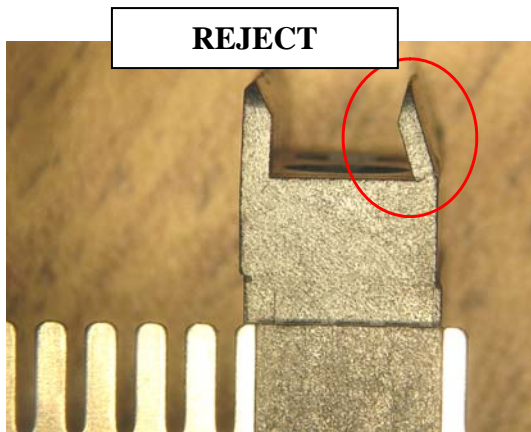
Figure 8.38 shows a guide module wing that is broken due to handling and may stub the guide pin during mating.

Figure 8.38 Guide module wall broken.

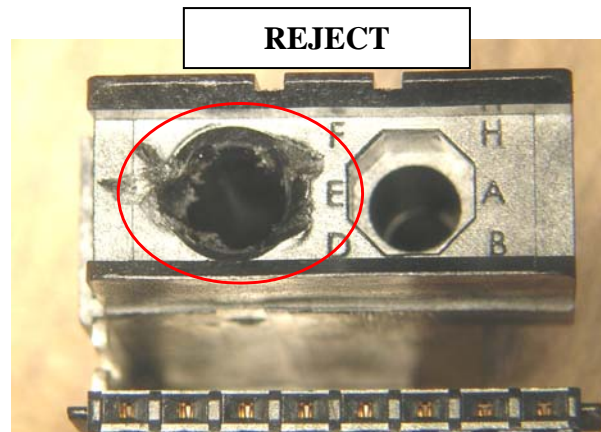
Figure 8.39 shows a guide pin hole that has a damaged lead in. Both of these conditions are to be rejected because they may impact the connector's ability to gather during mating.

Figure 8.39 Guide module hole damage.

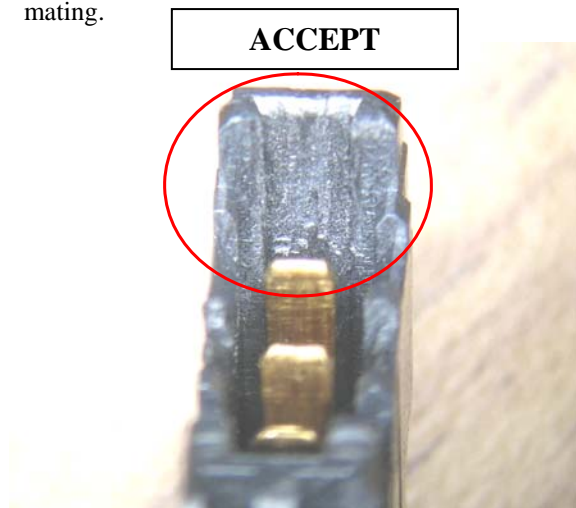
Figure 8.43 shows a wear track on the power module lead in entry from multiple mating cycles. Figure 8.44 shows a minor dent to the lead in area of the power module. Both of these conditions are acceptable. Dents along the mating face are acceptable as long as they do not impact the ability of the power module to mate without any binding effects. Figure 8.44 has a dent that does NOT protrude past the entry angle of the power module, therefore posing no risk to mating.

Figure 8.43 Wear track on power module

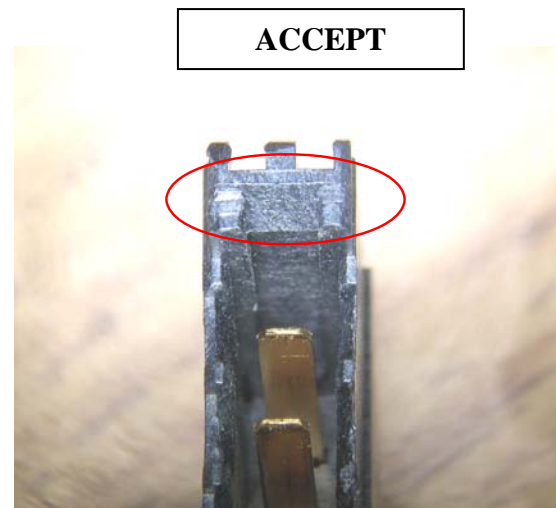
Figure 8.44 Dent on power module

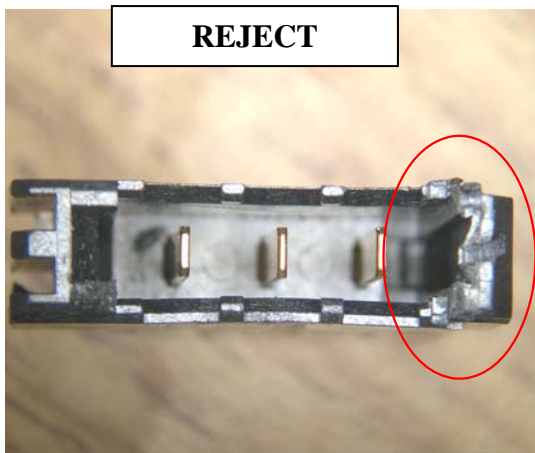
Figure 8.45 shows a dent in the lead in of the power module that is interfering with the ability of the power module to mate without binding. Figure 8.46 shows a blade that damaged and bent out of alignment. Both of these conditions are to be rejected and repaired per Amphenol-TCS recommendations (See Section 2.0).

Figure 8.45 Power window dent.

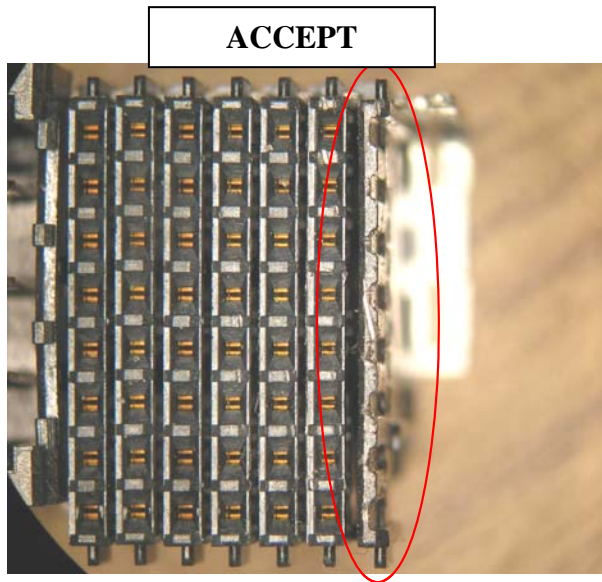
Figure 8.52 shows normal mating wear of the VHDM endcap. Figure 8.53 shows a crack on the main body of the endcap. Both of these conditions do not impact the mating ability or the mechanical strength of the endcap and are acceptable.

Figure 8.52. Dented 8 Row endcap mating face.

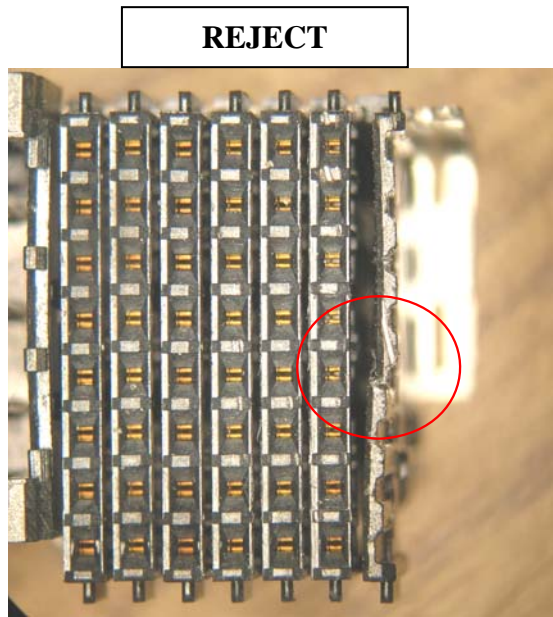
Figure 8.54 shows a mating face that is deformed and cracked. Figure 8.55 shows a board mounting peg that is broken. Both of these conditions are to be rejected and repaired per Amphenol-TCS recommendations (See Section 2.0).

Figure 8.54. Deformed 8 Row endcap mating face.

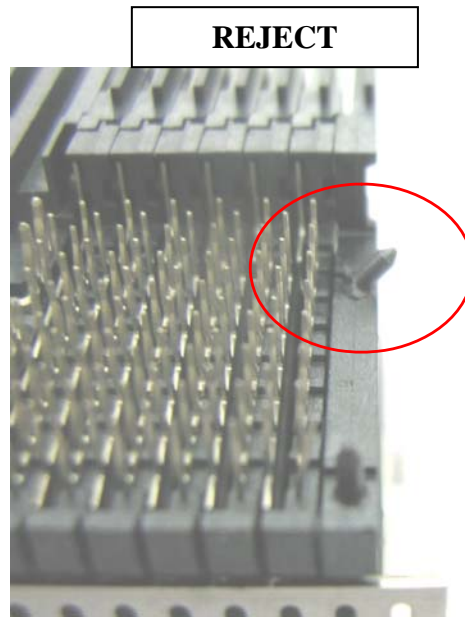
Figure 8.55. Broken board mounting peg.

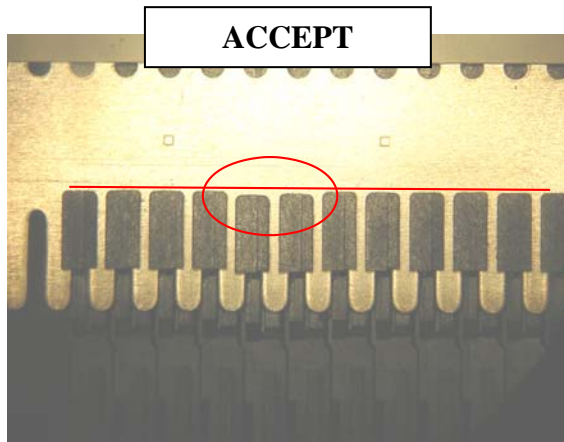
Figure 8.59 shows stiffener retention hats that are slightly lower than other retention hats. Figure 8.60 shows slight dents on the faces of the retention hats. Both of these conditions are acceptable. Height variation can be caused by variation in dimensions of the retention hat between components or due to slight seating variation (See Section 8.5.2). Slight surface dents to non critical areas of the retention hat such as the edges and corners of the hat will not compromise the feature's ability to adequately retain the component onto a stiffener. This is because the actual retention feature is only what is being "pinched" by the stiffener fingers.

Figure 8.59. VHDM stiffener hat height variation.

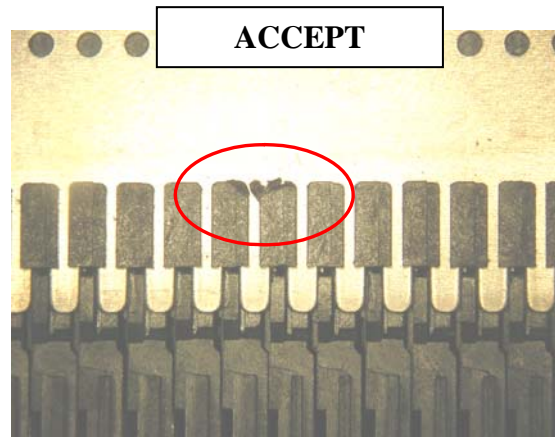
Figure 8.60. VHDM stiffener hat slight dent.

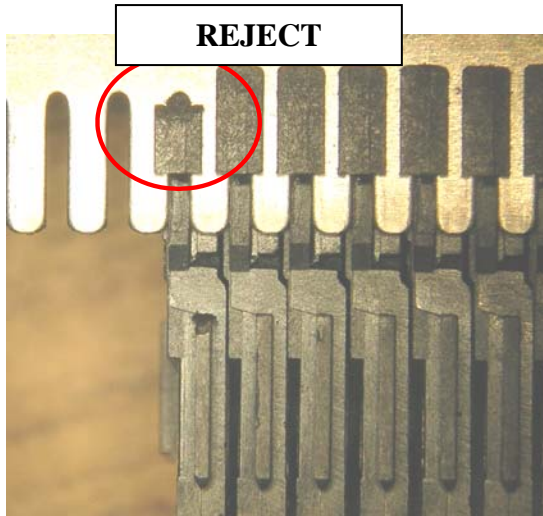
Figure 8.61 shows a retention hat missing the top portion of the hat. Although the retention of the component may still remain high, it is difficult to ensure that the retention hat is not damaged in other ways that cannot be seen. Figure 8.62 shows a missing top to the retention hat. Even if the retention hat rib is present, the component may still have lowered retention as a result of the defect. Both of these conditions are to be rejected and repaired per Amphenol-TCS recommendations (See Section 2.0).

Figure 8.61. Damaged VHDM stiffener hat.

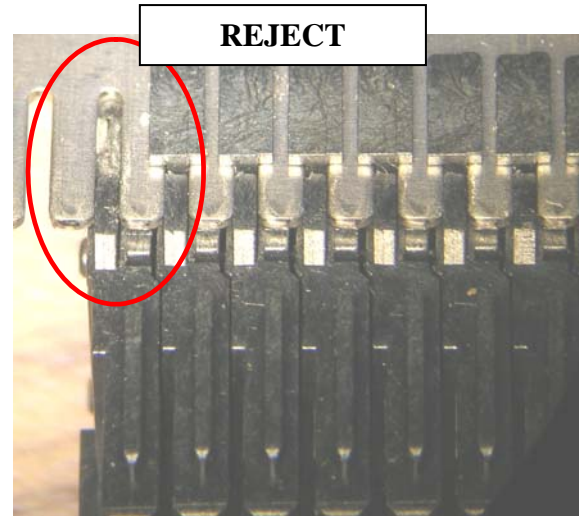
Figure 8.62. Missing VHDM stiffener hat.

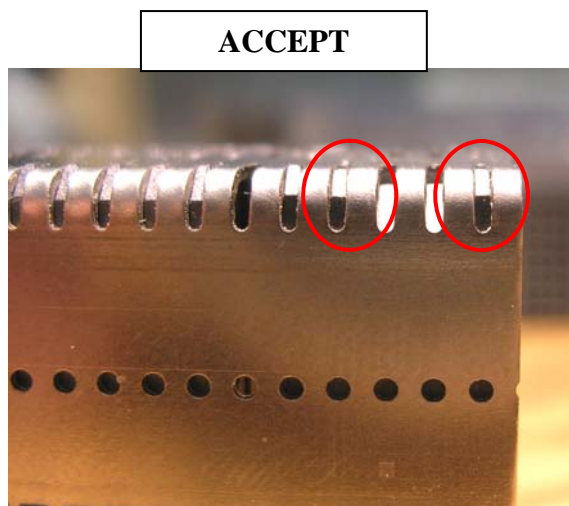
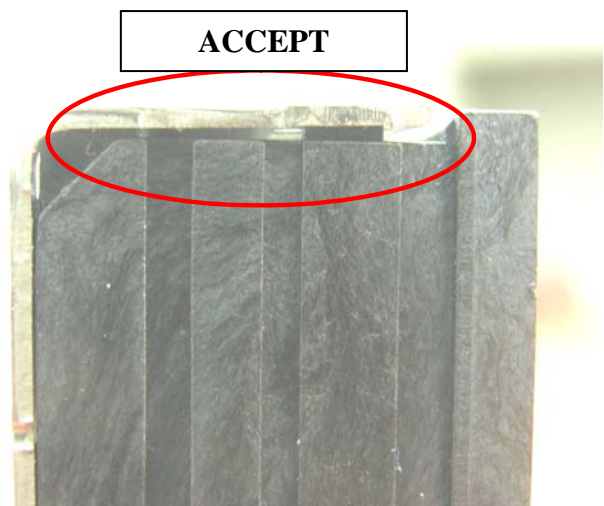
Figures 8.64 and 8.65 show a component seated onto a stiffener with the alignment tab partially engaged into a stiffener hole. Both of these conditions pose no risk to retention or alignment of the component on the stiffener and are acceptable as long as the alignment tabs protrude into the stiffener at least up to the stiffener thickness.

Figure 8.63. VHDM alignment tabs partially protruding. Figure 8.65. VHDM alignment tabs partially protruding.

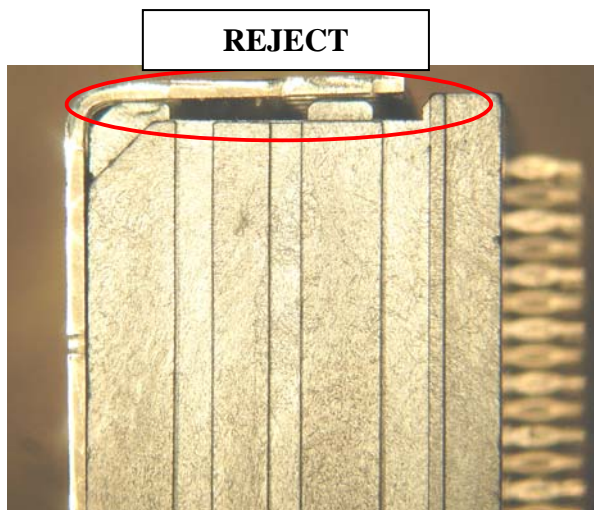
Both of these conditions are rejectable because they impact the seating, retention and alignment of the components on a stiffener. Any protrusion of an alignment tab less than a stiffener thickness is to be considered an under seated component and rejectable. These are to be repaired per Amphenol-TCS recommendations (See Section 2.0).

Figure 8.66. VHDM alignment tabs not protruding.

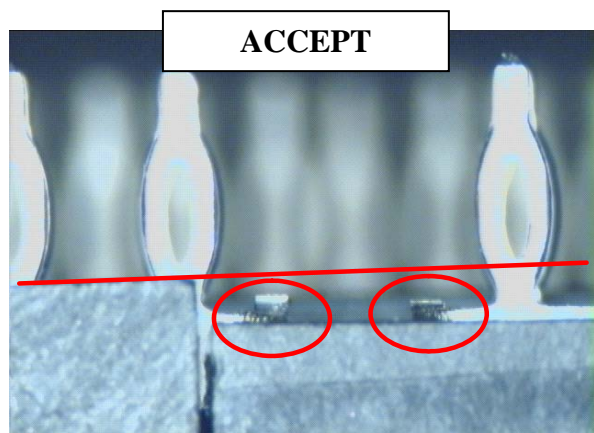
Figure 8.70 shows a complaint pin tie bar that is cut off slightly high, but below the component PWB standoff feature. Above the standoff feature is considered a KEEP-OUT zone. Figure 8.71 shows a complaint pin shoulder that is slightly twisted from an assembly process. Both of these conditions are acceptable.

Figure 8.70. VHDM tie bars below the standoffs.

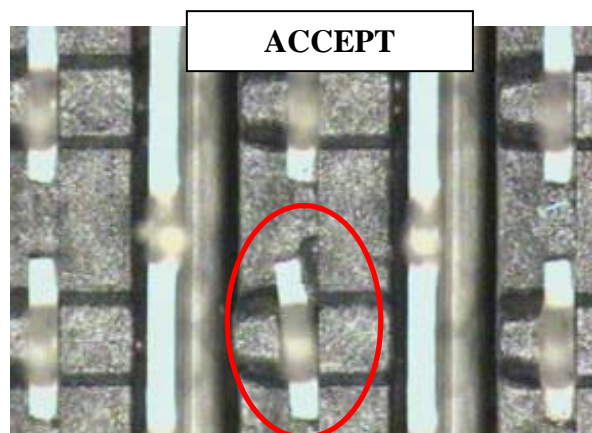
Figure 8.71. VHDM tie bars slightly bent.

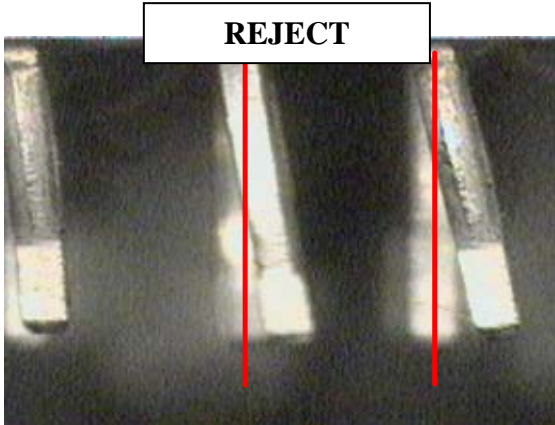
Figure 8.72 shows a compliant pin slightly bent with respect to other pins on the same connector. Figure 8.73 shows a grossly bent compliant pin in a VHDM pin field. Figure 8.74 shows a compliant pin field with a missing compliant pin. All of these conditions are to be rejected and repaired per Amphenol-TCS recommendations (See Section 2.0).

Figure 8.72. VHDM compliant pin bent.

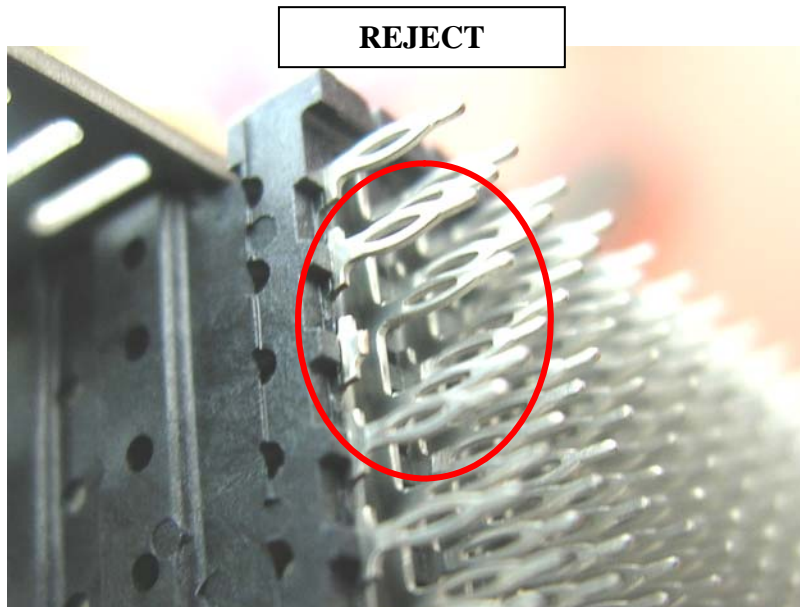
Figure 8.74. Missing Complaint pin.
