TB-2077

## WORKMANSHIP CRITERIA FOR VHDM DAUGHTERCARD CONNECTORS

Revision "M"

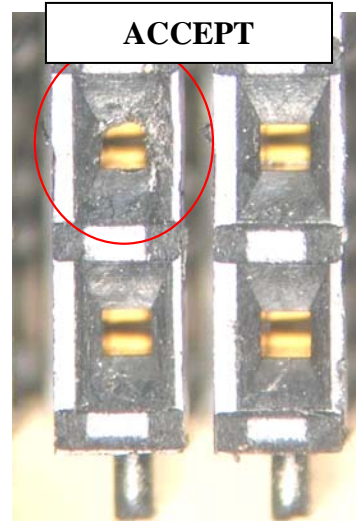
Figure 8.8 shows loose plastic from a window frame area protruding into the signal window. The plastic is loose and very thin in size. The plastic sliver is typically a result of the chevron of the shield conditioning to the mating wafer. Figure 8.9 shows signal pin lead in wear from multiple mating events. The lead in area only has surface wear and the window and shape of the lead in is still in tact. This wear will not impact the mating process. Any dent in the mating window under  $\frac{1}{2}$  of the signal pin size is acceptable and will not impact mating. Both conditions are a result of normal mating cycling and are acceptable.

Figure 8.9 Signal pin window lead in wear tracks.

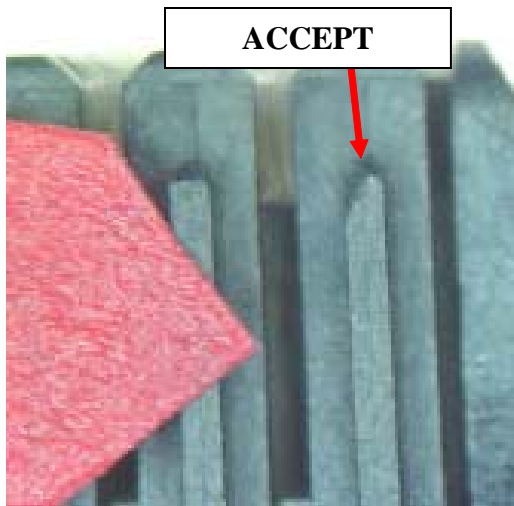
Figure 8.21 shows a mating rib with a slight scraping of the tip. This is acceptable because the tip center is still in tact and will provide functional gathering of the wafer. Figure 8.22 shows a mating rib tip with a slight dent. This is acceptable because the outer edge of the tip is in tact, providing gathering capabilities of the wafer.

Figure 8.21. Mating rib tip scrape.

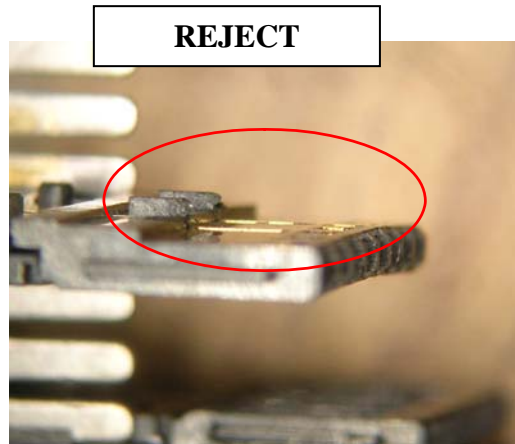
Any damage to the shield fingers that bends or breaks the fingers is to be rejected and repaired as recommended by Amphenol-TCS (See Section 2.0). Figure 8.31 shows a bent shield finger. Figure 8.32 shows missing shield fingers. Both of these conditions are to be rejected.

Figure 8.32 Ideal shield fingers.

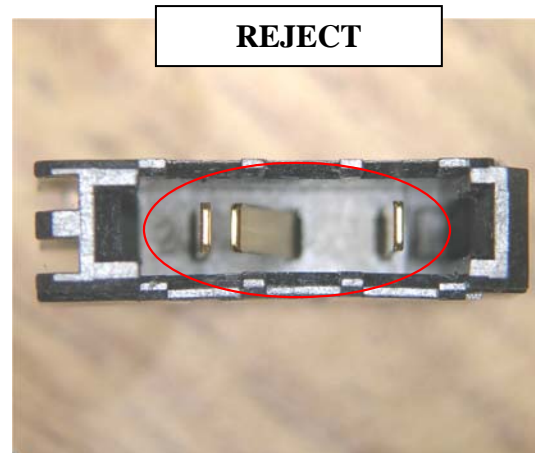
Figure 8.45 shows a dent in the lead in of the power module that is interfering with the ability of the power module to mate without binding. Figure 8.46 shows a blade that damaged and bent out of alignment. Both of these conditions are to be rejected and repaired per Amphenol-TCS recommendations (See Section 2.0).

Figure 8.46 Bent power blade.

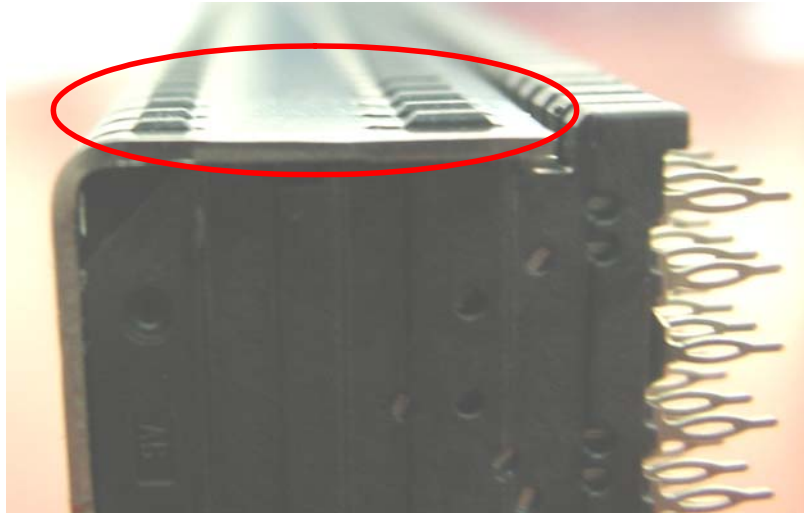
Figure 8.63. VHDM alignment tabs fully protruding.

Figure 8.63 shows ideal alignment tabs fully protruding through stiffener holes.

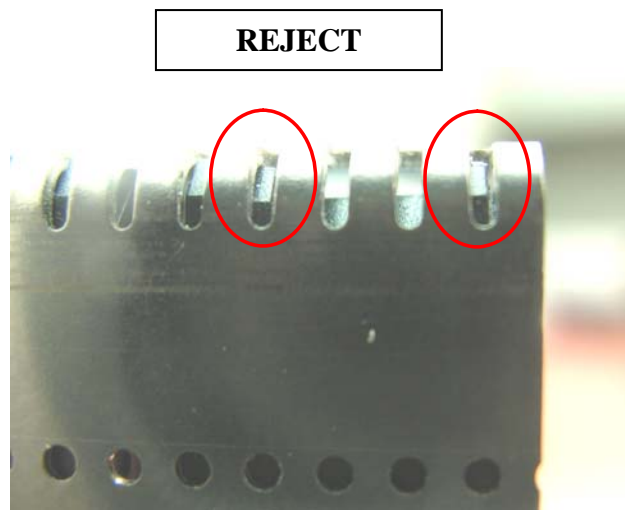
Figure 8.67. VHDM alignment tabs not protruding.

Figure 8.67 shows a component seated onto a stiffener with the alignment tabs also not engaged into a stiffener hole.

Both of these conditions are rejectable because they impact the seating, retention and alignment of the components on a stiffener. Any protrusion of an alignment tab less than a stiffener thickness is to be considered an under seated component and rejectable. These are to be repaired per Amphenol-TCS recommendations (See Section 2.0).

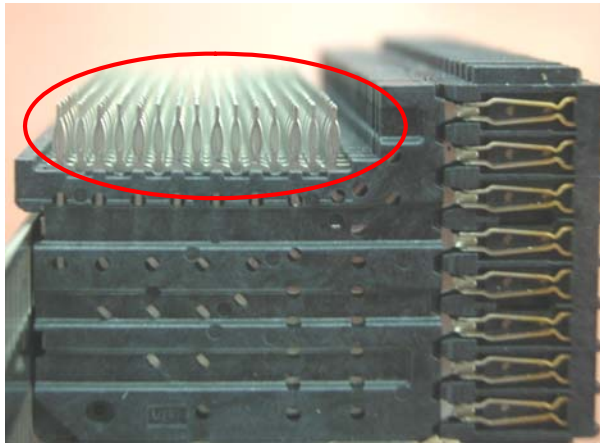
Figure 8.68. VHDM complaint pins properly aligned.

Figures 8.68 and 8.69 show ideal alignment of VHDM complaint pins.

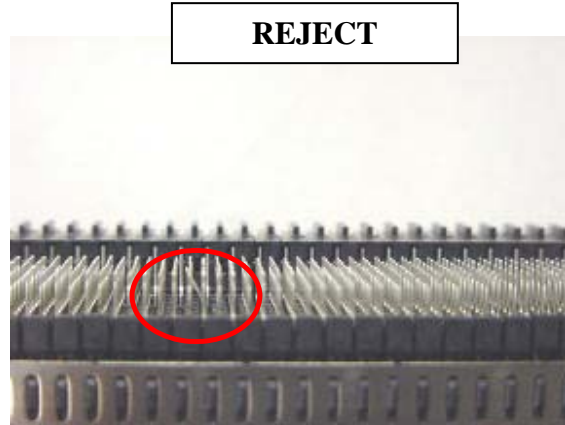
Figure 8.73. VHDM complaint pin bent.

Figure 8.72 shows a compliant pin slightly bent with respect to other pins on the same connector. Figure 8.73 shows a grossly bent compliant pin in a VHDM pin field. Figure 8.74 shows a compliant pin field with a missing compliant pin. All of these conditions are to be rejected and repaired per Amphenol-TCS recommendations (See Section 2.0).

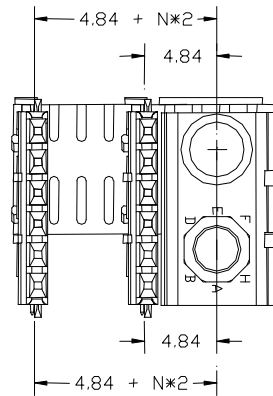
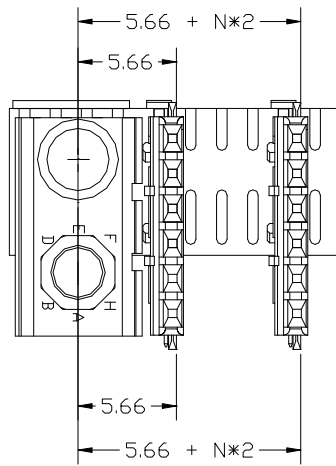
9.3.2 The wafer position is measured on connectors using the guide module as the starting point. The center of the guide pin, mating receptacle is set as the origin for measurement. The wafers are then measured, with respect to the guide module, using the alignment tabs as the measured features. The measurements are taken from the center of the guide pin, mating receptacle to the far end of the alignment tabs, depending on the direction of measurement – i.e. the position of the wafers relative the guide module. See Figures 9.1 and 9.2 for feature dimensions and measurement.

FIGURE 9.1: WAFERS LOCATED TO THE LEFT OF THE GUIDE

FIGURE 9.2: WAFERS LOCATED TO THE RIGHT OF THE GUIDE

- 9.3.3 In Figures 9.1 and 9.2, 'N' represents the number of stiffener slots after the first wafer. The tolerance on the wafer position is +/- 0.35mm. This value is to be measured on a connector that is applied to a PWB as wafer position is greatly influenced by PWB hole positions as well as connector seating tooling and processes. Chart 1 below is an example of a connector with 10 wafers to the right and left of a guide module, with no empty spaces between the guide module and/or the wafers.

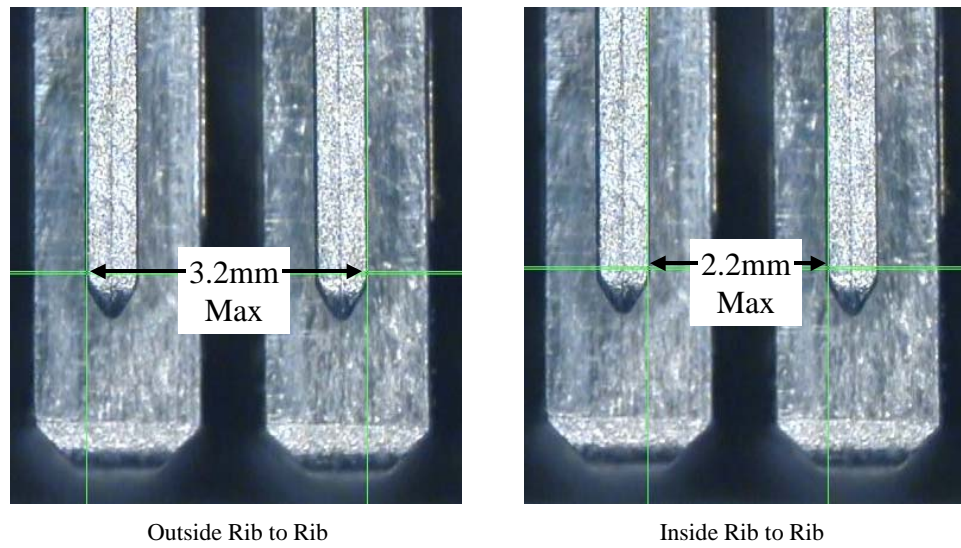
- 9.4.1 In the case that measurement from the guide receptacle is not possible, a criteria between wafers has been established. This criteria applies for any wafer and/or wafer/endcap combination.
- 9.4.2 The distance between adjacent wafer alignment ribs is not to exceed 2.2mm. The distance to the outside of adjacent ribs is not to exceed 3.2mm. These dimensions are based on the nominal dimensions between ribs plus the maximum tolerance as noted in CHART 1 above.
- 9.4.3 If an optical measurement system is used to check this dimension, the rib spacing should be measured above the lead-in at the tip of the rib according to the criteria above. See Figure 9.3.

Figure 9.3 Measurement from wafer rib to wafer rib.

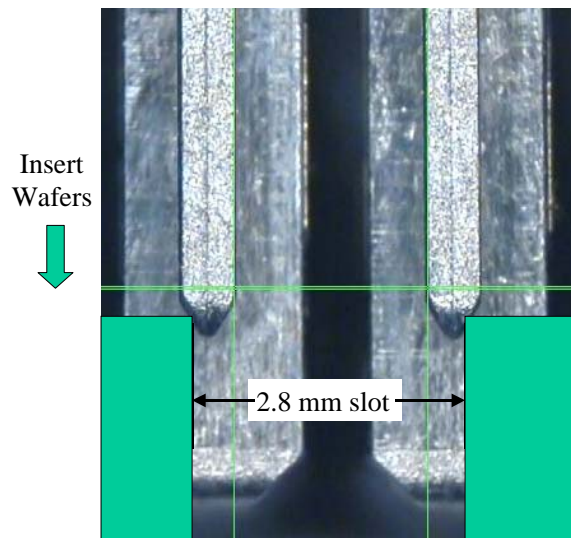
9.4.4 If a gauge is used to check this dimension, the rib tip lead-ins will be accounted for. The gauge should be designed such that the outside rib-to-rib dimension does not exceed 2.8mm. If two consecutive wafer ribs cannot be inserted into a 2.8mm slot, the part is considered defective. See Figure 9.4.

Figure 9.4 Gauge measurement of wafer rib position.
